Measuring the Impact of a Landslide on Transportation Infrastructure to Improve Mobility and Safety

Margaret M. Darrow
 Ronald P. Daanen
 Jaimy A. Schwarber

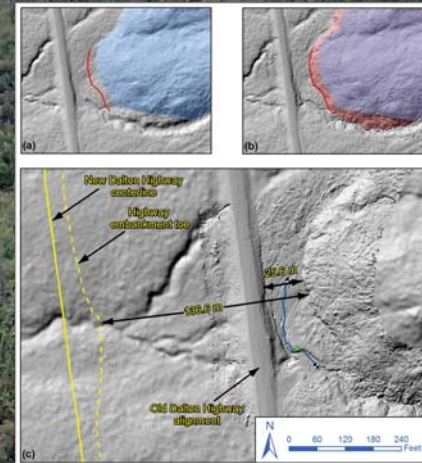
Figure 4. LiDAR data sets comparison and highway embankment configurations. The background image in (a) is 2015 LiDAR with 1-m resolution; the 2015 FDL-A toe position is defined as the shaded blue area, and 2018 DGPS toe measurements are shown in red. The background in (b) is a combination of the 2015 LiDAR and the 2018 LiDAR. The 2018 FDL-A extent is the shaded red area. Subfigure (c) details the July 2018 distances between FDL-A and the old and new Dalton Highway alignments.

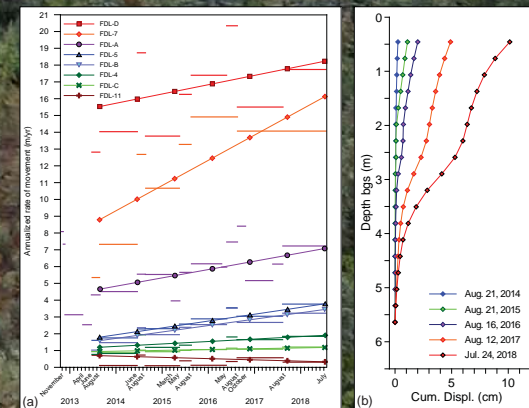
- Most FDLs continue to demonstrate increasing rates of movement with time
- FDL-A is affecting the subsurface ahead of it, with pronounced movement to 2.5 m bgs, and even shearing into the weathered bedrock (occurring at 3 m bgs at TH12-9000)
- Based on 2017/18 readings, FDL-A is moving at 7.2 m/yr; based on its current distance and rate, it will reach the original Dalton Highway by 2022 and the realignment by 2038

Figure 5. Ongoing monitoring results: (a) overall movement rates from eight studied FDLs; (b) inclinometer readings from TH12-9000.

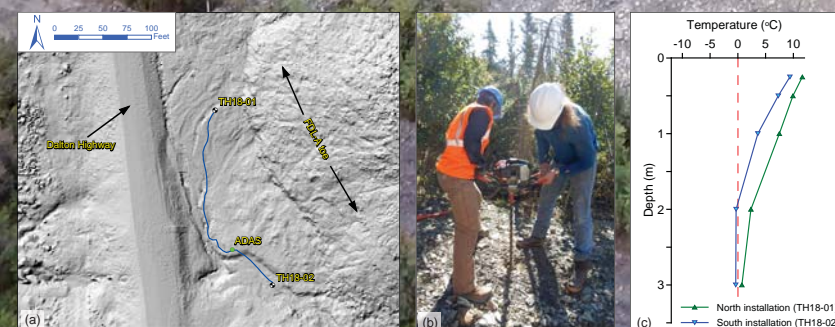
- Drilled two 3-m deep borings with 6.4-cm dia. auger and power head; intercepted water in each boring
- Installed vibrating wire piezometer and thermistor string in each boring
- Routed cabling to automated data acquisition system (ADAS); added air and surface temperature sensors
- Temperatures indicate frozen conditions at the bottom of TH18-02

Figure 2. Overview of 2018 geomechanical instrument installation: (a) locations of borings and ADAS; (b) drilling with auger and power head; (c) preliminary temperature profile data from both borings. Background image in (a) is 2018 LiDAR DEM, collected as part of this project.
