# Internal Creep Dynamics of Frozen Debris Lobe-A, Brooks Range, Alaska (GC31H-1198)

Margaret M. Darrow and Ronald P. Daanen

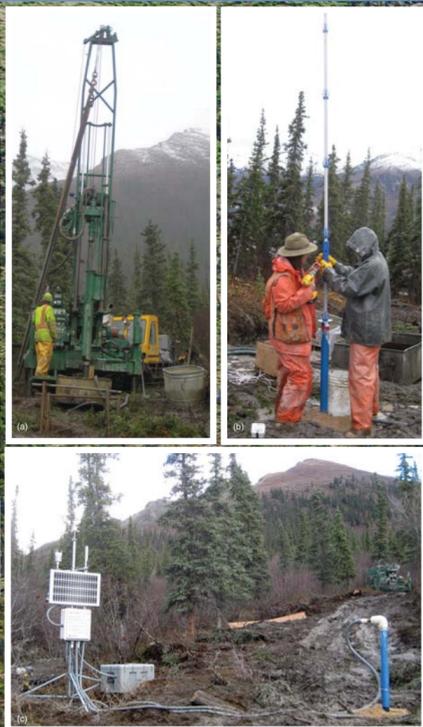
- Silty sand with gravel (SM) to 26.4m bgs; overlying chloritic schist bedrock (location of borehole indicated by red circle on FDL-A)
- Installed:
  - Thermistors
  - Vibrating wire piezometers
  - MEMS-based in-place inclinometer (M-IPi)
  - Weather station
  - Automated data acquisition system (ADAS)
- M-IPi characteristics:
  - 8-ft long flexible modules
  - MEMS-based accelerometer sensors, measure tilt
  - Accelerometer and temperature sensors located every 0.3m
  - Connected by underwater electrical connectors; stiffened by coupler assembly
  - 3 to 4 centralizers guide M-IPi into slotted casing

Figure 2. 2012 subsurface investigation. (a) CME 850X track-mounted drill rig; (b) installing the M-IPi; (c) completed installation.

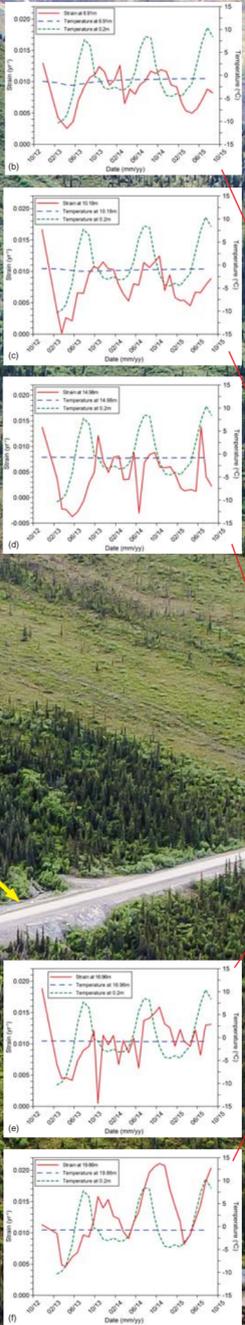
- Cyclical strain pattern is present for all depths
- Temperature at depth does not demonstrate cyclical pattern
  - Temperature indicates slight warming
  - Less than 0.1°C change at depth
- Cyclical strain pattern matches surface temperature pattern with a four-month offset
  - Temperature peaks in late June; strain peaks in late October

Figure 5. Graphical representation of TH12-9004, indicating frozen zones, depths of noted water pressure and wood fragments, and the shear zone (a). Graphs of strain and temperature at five depths are presented as (b) - (f).
