Measuring the Impact of a Landslide on Transportation Infrastructure to Improve Mobility and Safety

Margaret M. Darrow
 Ronald P. Daanen
 Jaimy A. Schwarber

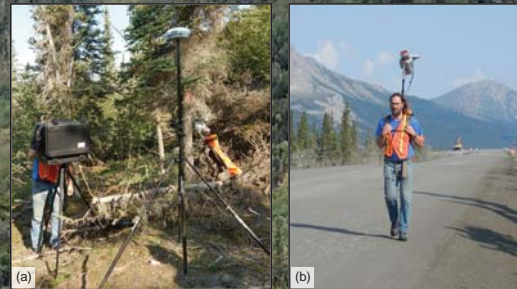
Figure 3. Acquiring 2018 LiDAR: (a) setting up base station; (b) collecting LiDAR data in back-pack mode.

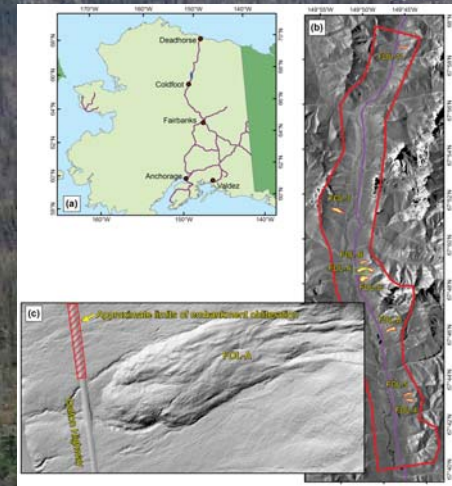
Figure 1. Location of the project area (a) relative to major communities along the Dalton Highway, northern Alaska. The blue rectangle in (a) indicates the location of map (b), which illustrates the area of interest (AOI). The AOI is indicated by the red polygon, the Dalton Highway is in purple, the Trans Alaska Pipeline System (TAPS) is in green, and the investigated FDLs are in yellow. The map in (c) is lower portion of FDL-A, indicating the location of the original Dalton Highway.
